Diamond Head

DATE: November 27, 1979

SUBJECT: Report of findings, second inspection of in-situ emergency oil-water separation system at Diamondhead Refining Co., Inc., Kearny, N.J.

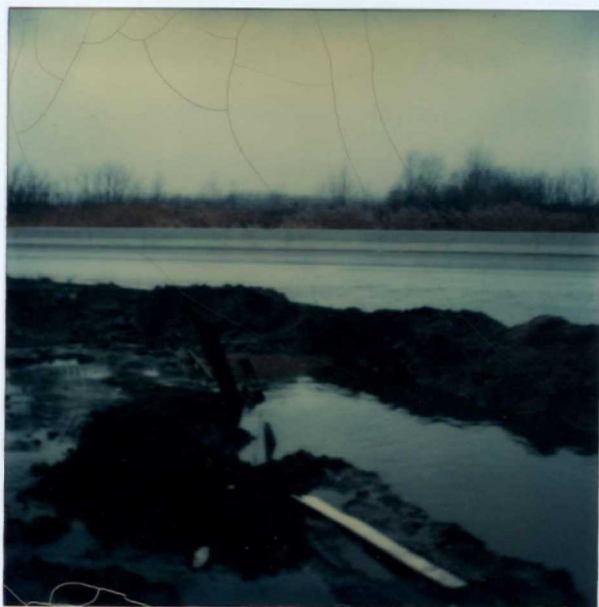
3. Separator: No evidence of flooding. Wind had accumulated oily froth at inlet end of separator (volume approximately 250 ml, see photo). First chamber non-existent. Erosion around both sides of filter fence could result in by-pass of media and discharge of accumulated oil if 180° wind change occurred. Water behind filter fence and flowing over outfall wier was free of oily sheen.

Photo I. Inlet to Separator. Note emulsified, floating oil accumulated downwind.

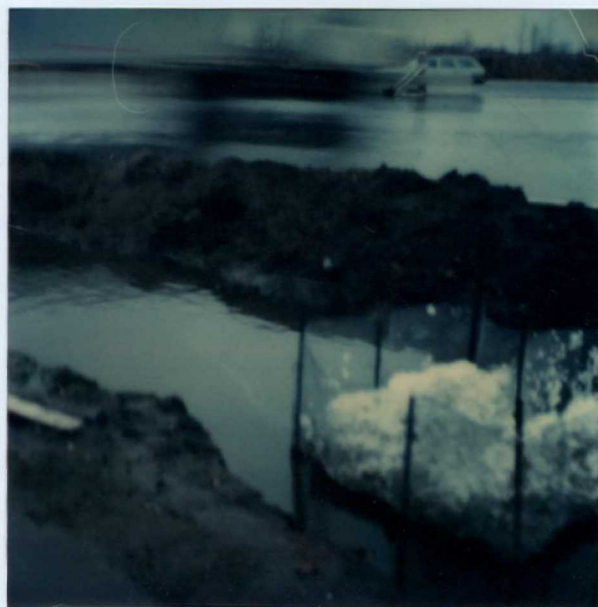
Photo II. Location of "First Chamber". Note absence of baffle or earth partition, short-circuiting to filter fence.

Conditions at the site on November 26, 1979, strongly suggest that the principal source of oil contamination is not presently from Diamondhead runoff, but originates on what is now state-owned lands. Although up-grading the separator as per my November 6 letter would

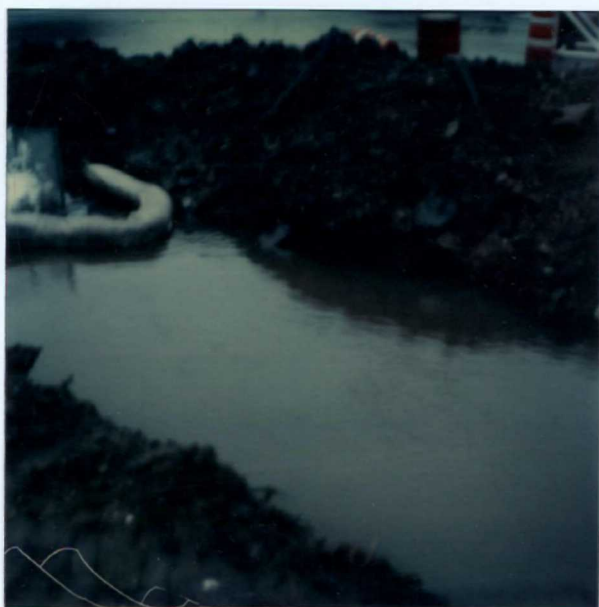
Photo III. Water surface behind filter fence. Note absence of oily sheen.

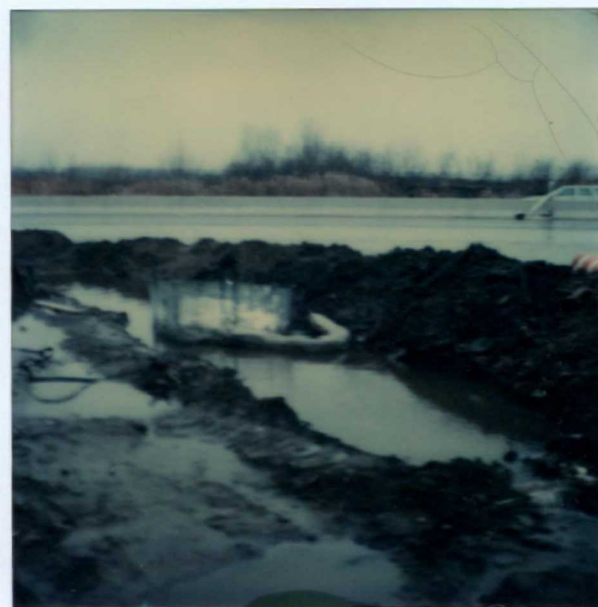
Photo IV. Overall view of separator. Note by-pass around filter fence. (Due to poor lighting, no tripod, close-up shots of separator were too blurry to be of value.)

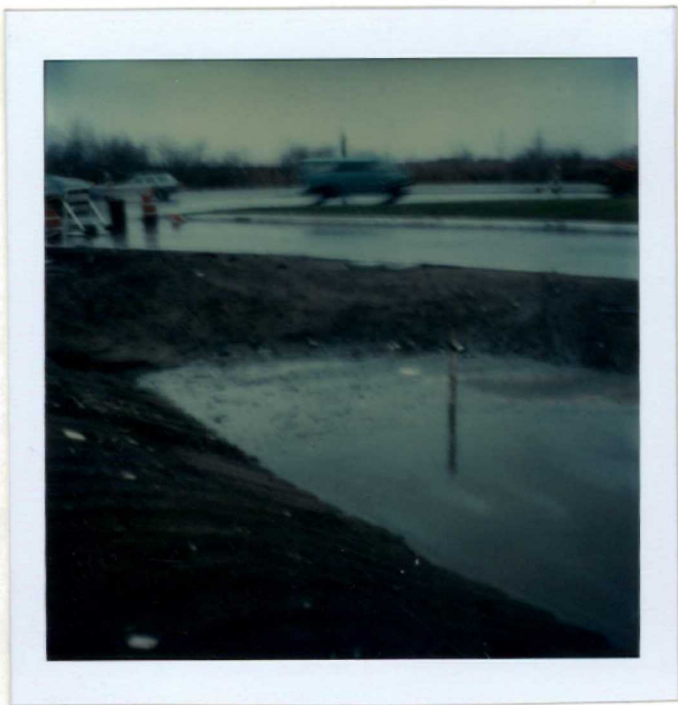
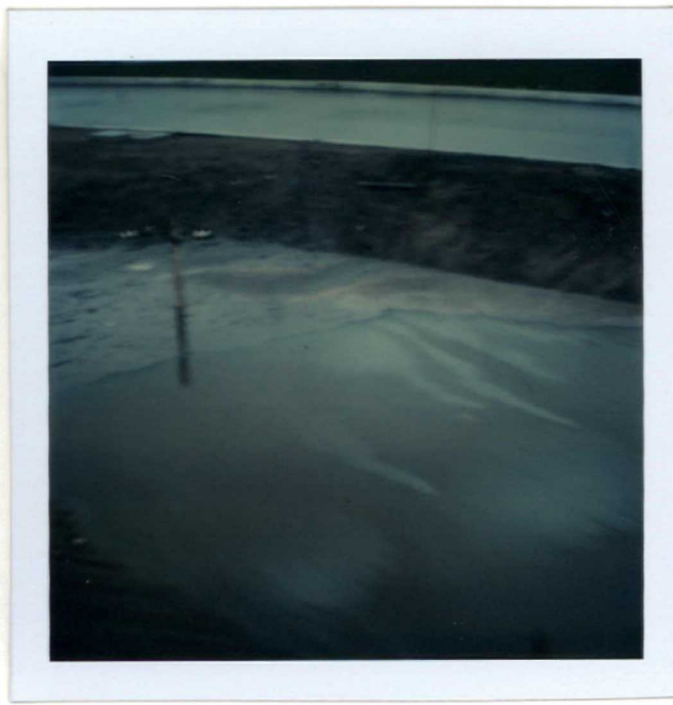
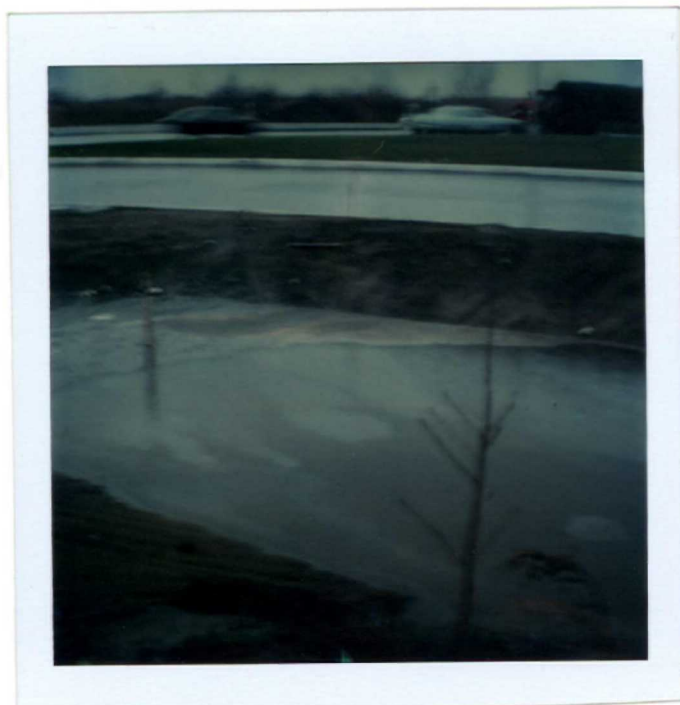
4. Receiving Ditch: Approximately 60 liters (16 gallons) of emulsified oil and oil-soaked debris had accumulated at the northern terminus of the drainage ditch. As the photos indicate, the source of this oil was not Diamondhead's discharge, but from the oily leachate and oil-soaked solids originating in the fill surrounding and below the ditch.

Photos V, VI, and VII. Downwind accumulation of oily emulsion and debris. Note the movement of oily sheen from discrete particles of floating oily solids carried into accumulation by gusty winds.

improve efficiency, this action would not eliminate the continuing oil seepage into the ditch. This inspection confirmed N.J.D.O.T. Resident Engineer, Mr. Steinberg's, suspicions of continuing problems with the oily fill. His suggestions for containment and collection systems at one or more locations within the Interstate 280 interchange drainage system, before these flows enter surrounding drainage systems or creeks, are well-taken and should be pursued.
